**City of Los Angeles
WATERSHED PROTECTION DIVISION
ENVIRONMENTAL ENFORCEMENT & EMERGENCY RESPONSE UNIT**

CASE #52967

Spill/Fire Investigation

Case #52967 – 210 W Slauson Ave – fuel spill and tanker fire
Prepared by Environmental Compliance Officer Cook

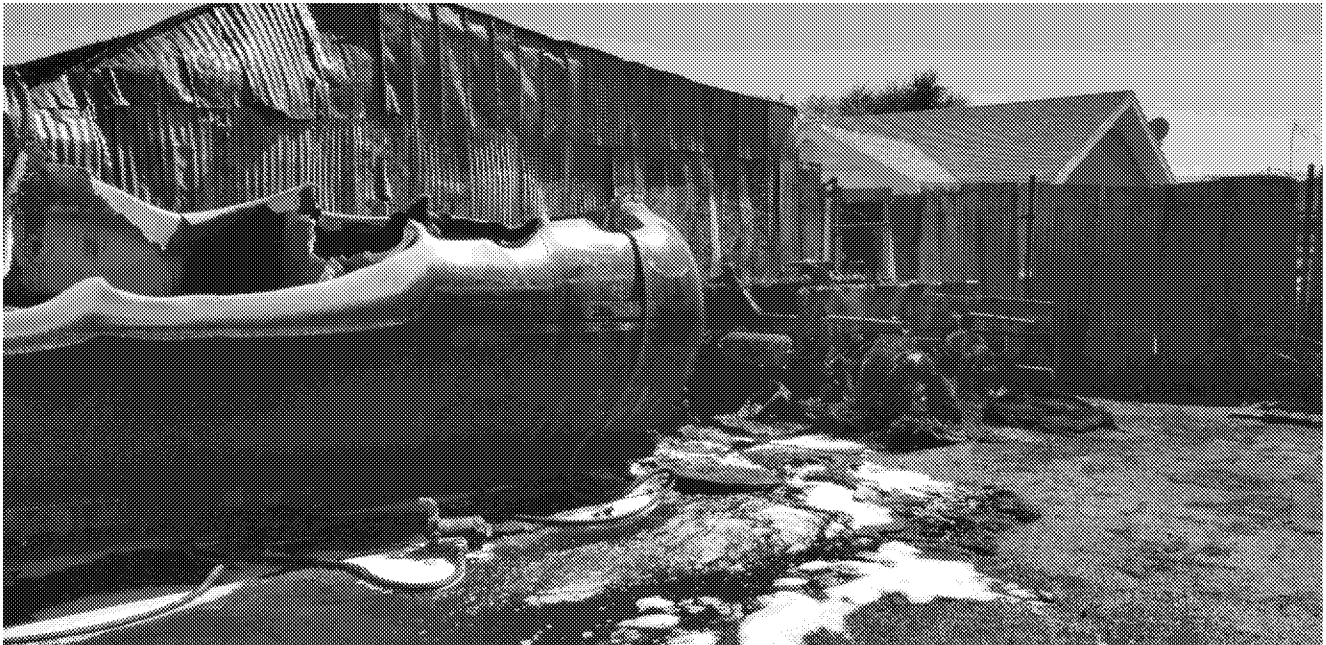
Figure #26.

View facing southeast at 210 W Slauson Ave, Parcel A, with fire-damaged “tanker” and fire-damaged wheels-and-axles component. Ground pooling is likely a mixture of fuel, water and fire retardant.

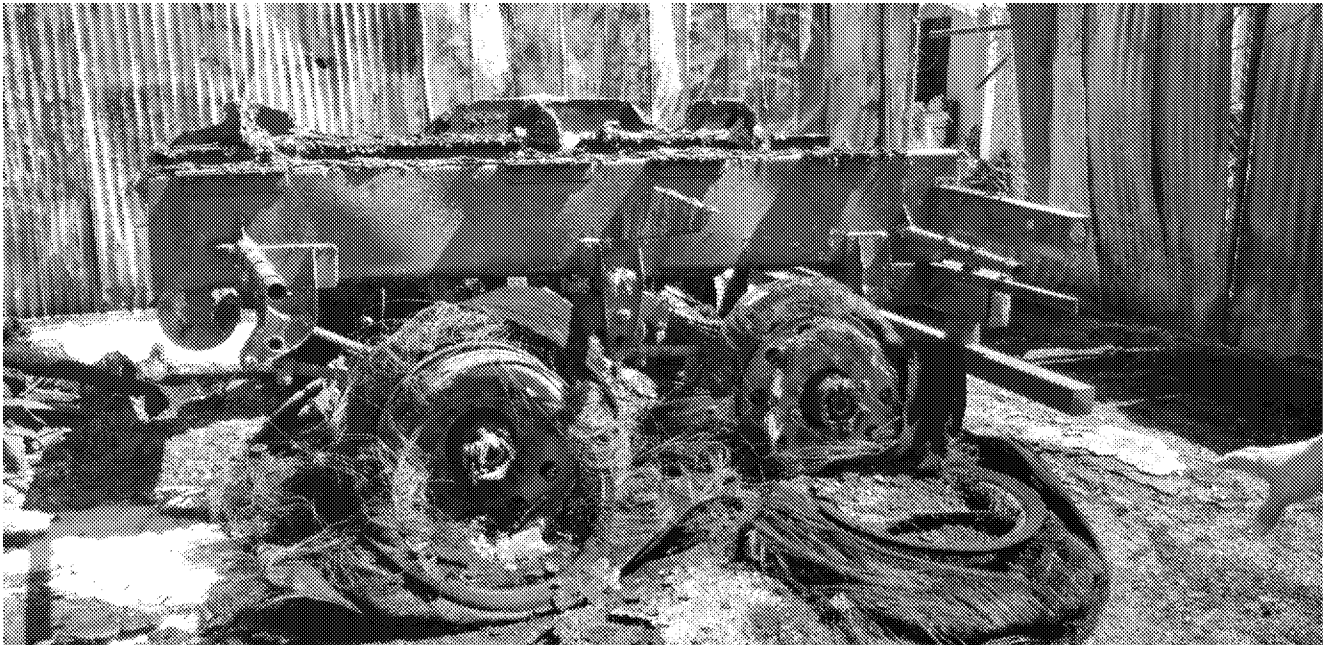
Figure #27.

View facing east at 210 W Slauson Ave, Parcel A, with fire-damaged wheels-and-axes component.

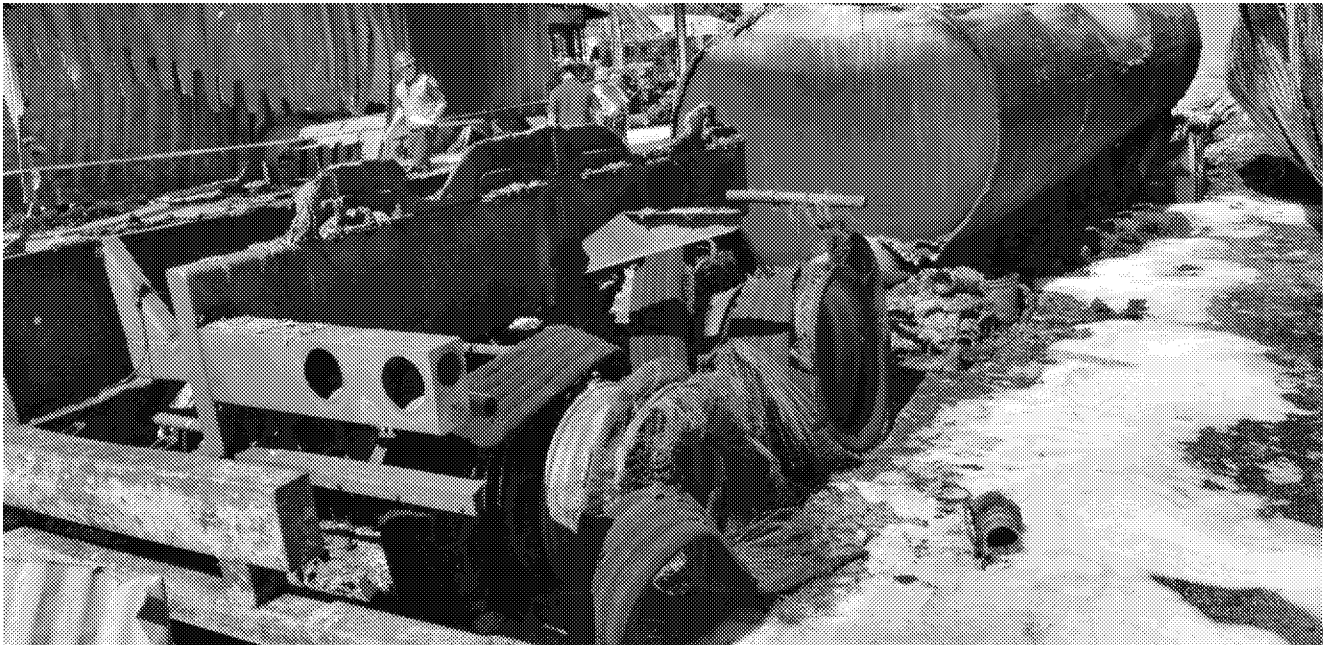
Figure #28.

View facing northwest at 210 W Slauson Ave, Parcel A, with fire-damaged wheels-and-axles component and fire-damaged “tanker.” Ground pooling likely a mixture of fuel, water and fire retardant.

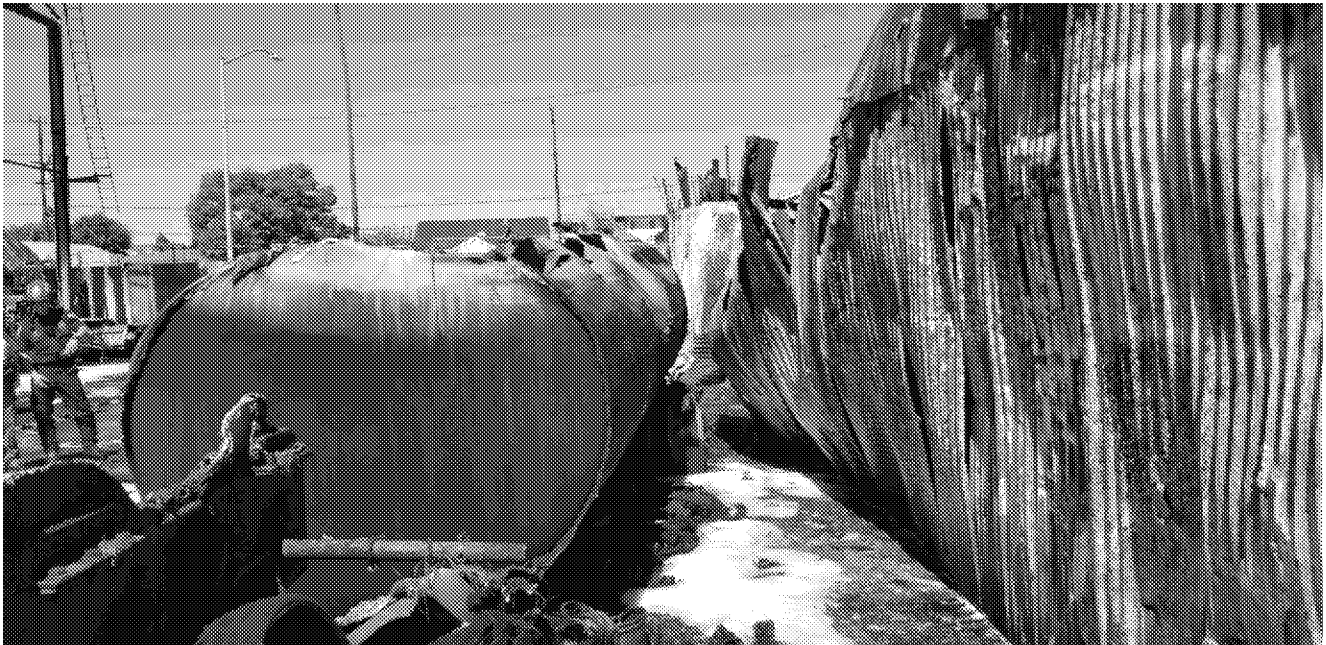
Figure #29.

View facing north at 210 W Slauson Ave, Parcel A, with fire-damaged “tanker” and fire-damaged fencing separating Parcel A from Parcel B. Ground pooling likely a mixture of fuel, water and fire retardant.

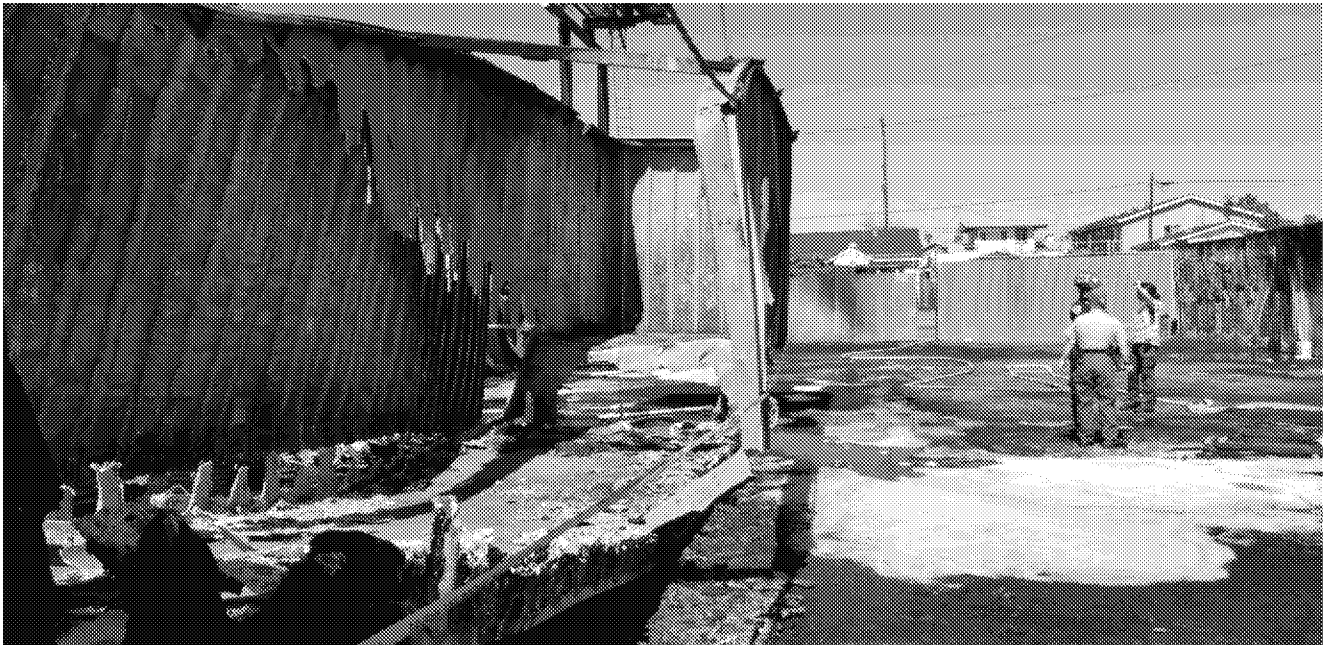
Figure #30.

View facing north at 210 W Slauson Ave, Parcel A, with a fire-damaged trailer. Ground pooling likely a mixture of fuel, water and fire retardant.

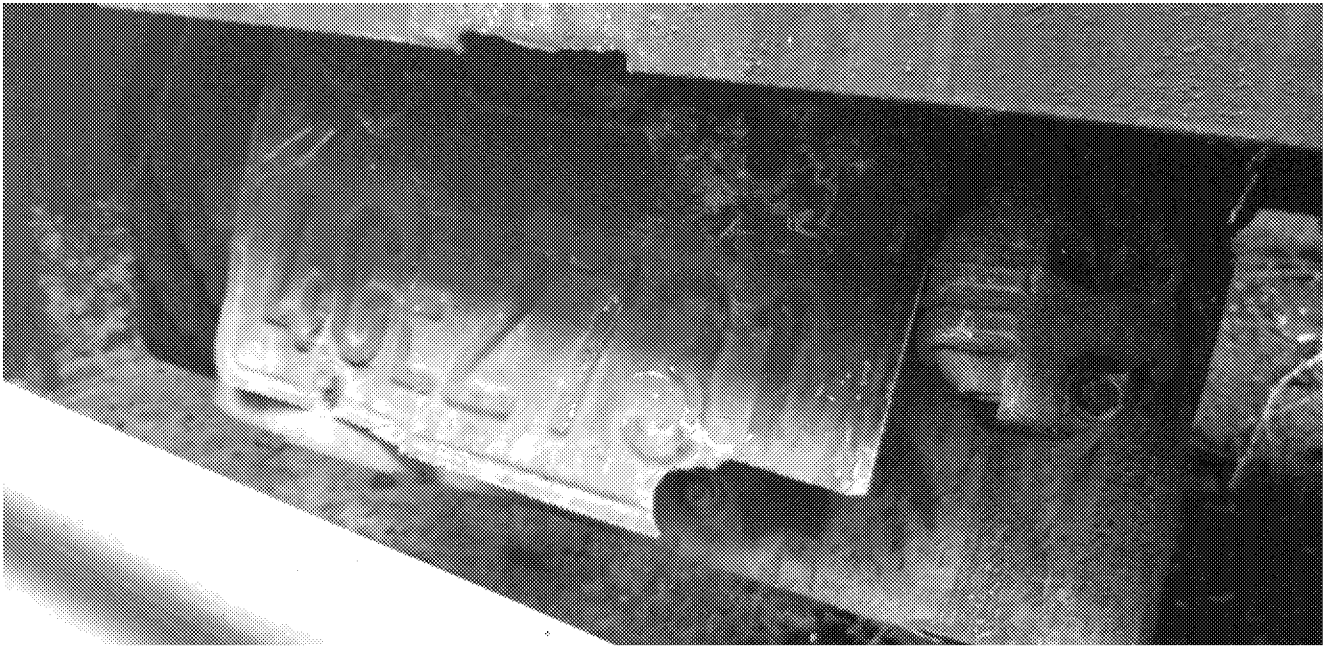
Figure #31.

Close-up view of license plate of same trailer pictured in Figure 25, 4GE2731.

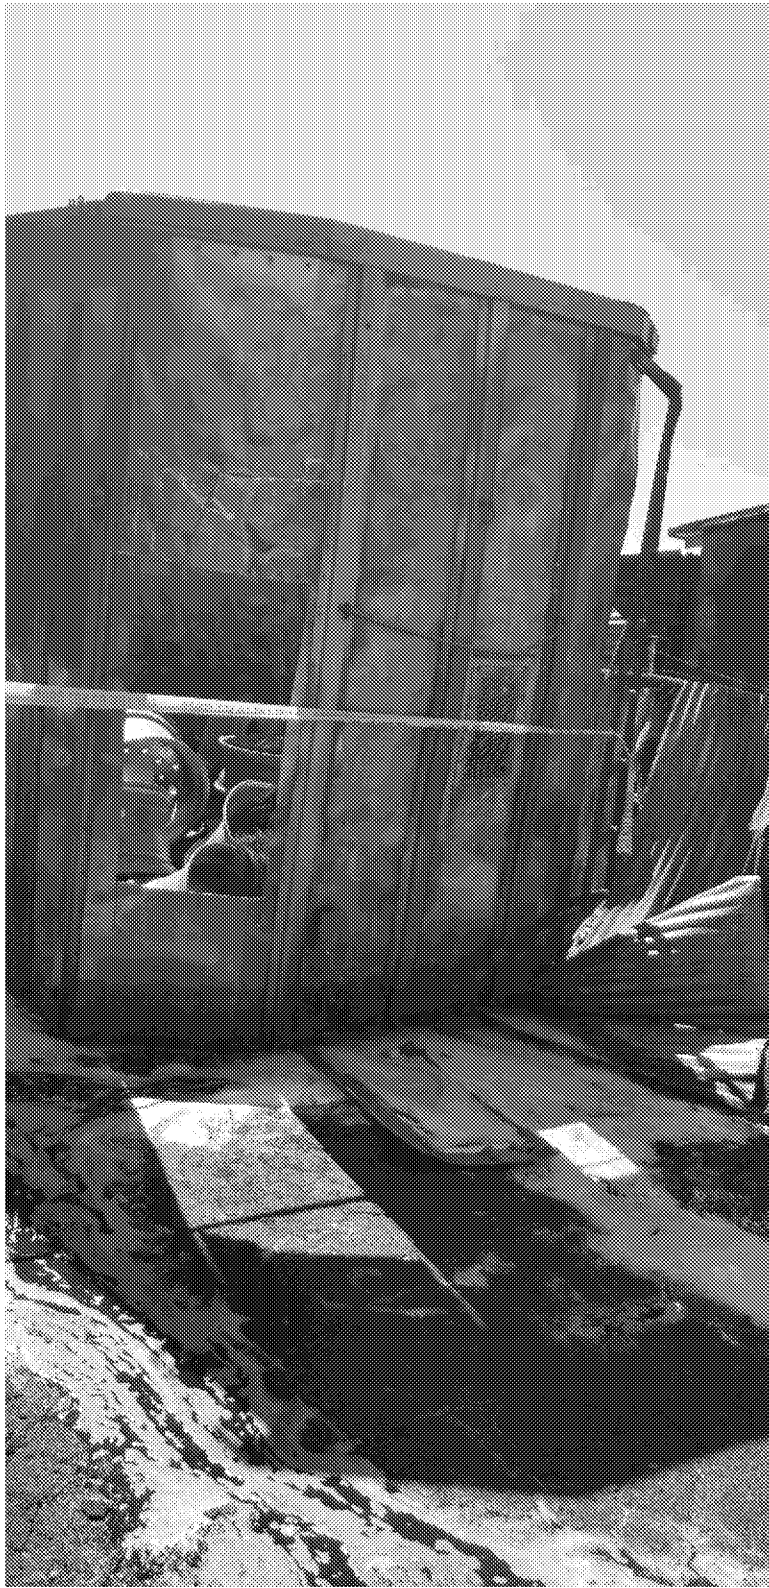
Figure #32.

View facing southwest at 210 W Slauson Ave, Parcel A, with a second fire-damaged trailer.
Ground pooling likely a mixture of fuel, water and fire retardant.

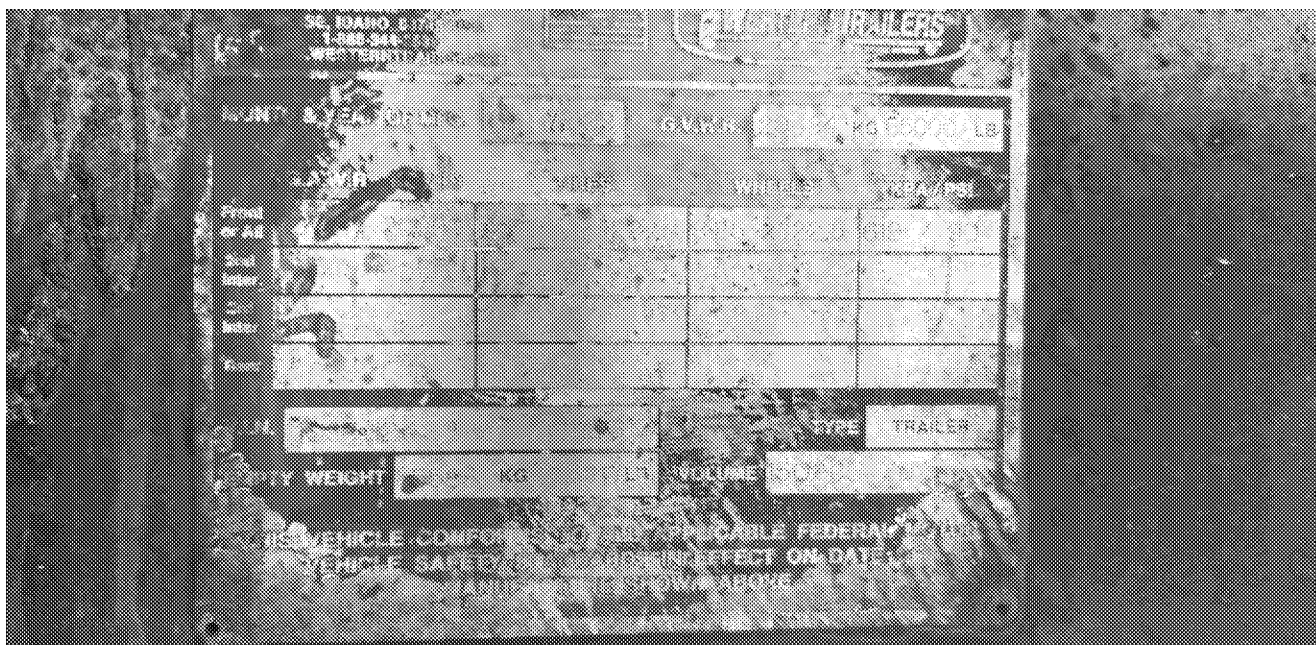
Figure #33.

Close-up view of fire-damaged information plate of same trailer pictured in Figure 27.

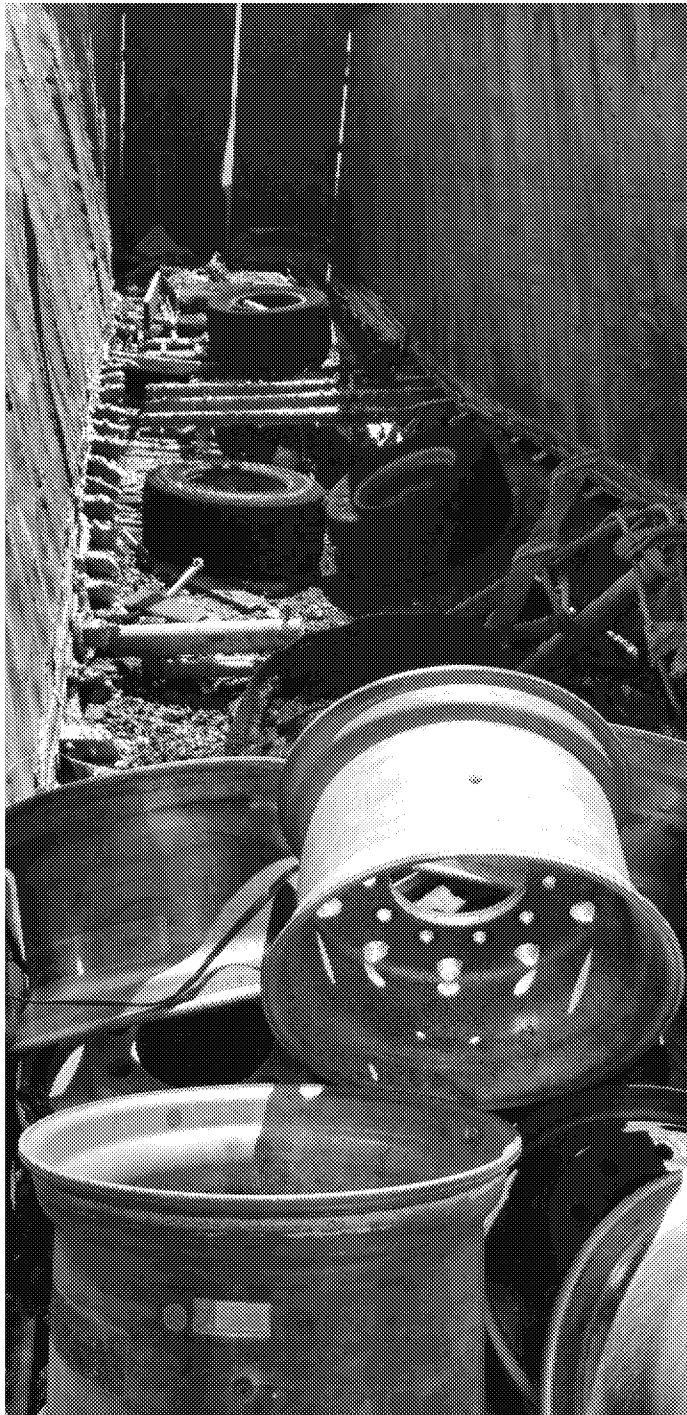
Figure #34.

View facing south at 210 W Slauson Ave, Parcel A, inside the fire-damaged trailer pictured in Figure 27.

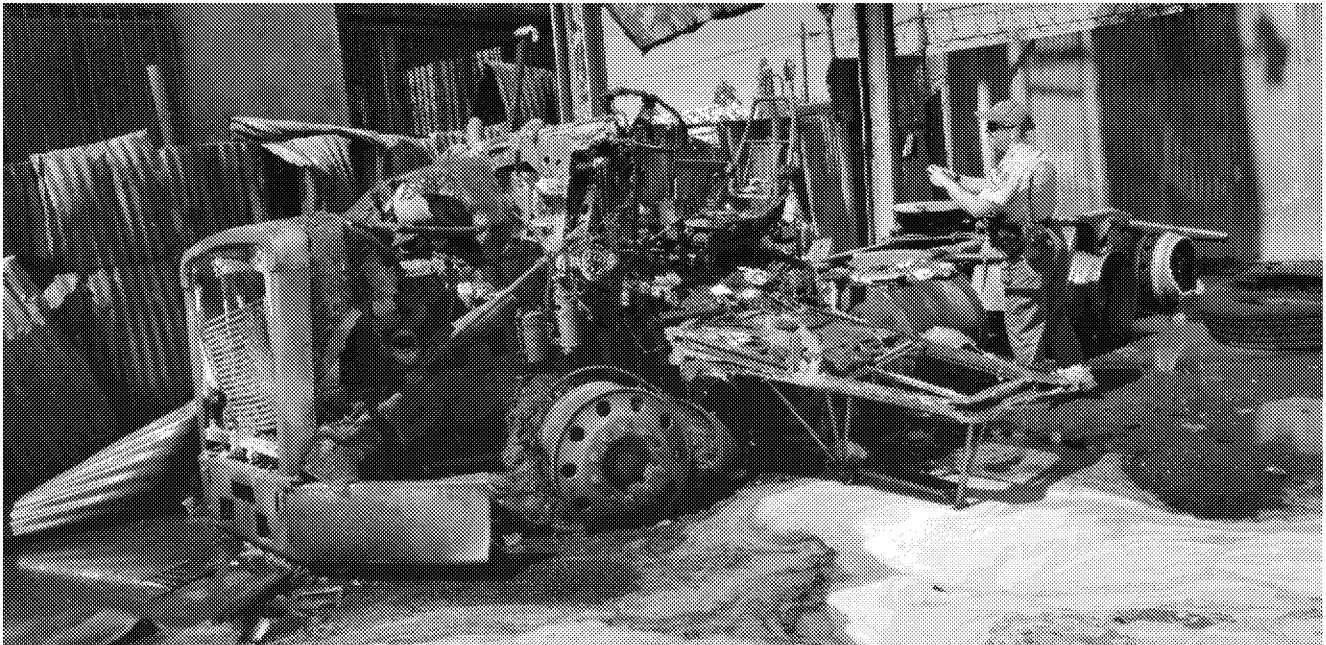
Figure #35.

View facing northwest at 210 W Slauson Ave, Parcel A, with a fire-damaged vehicle. Ground pooling likely a mixture of fuel, water and fire retardant.

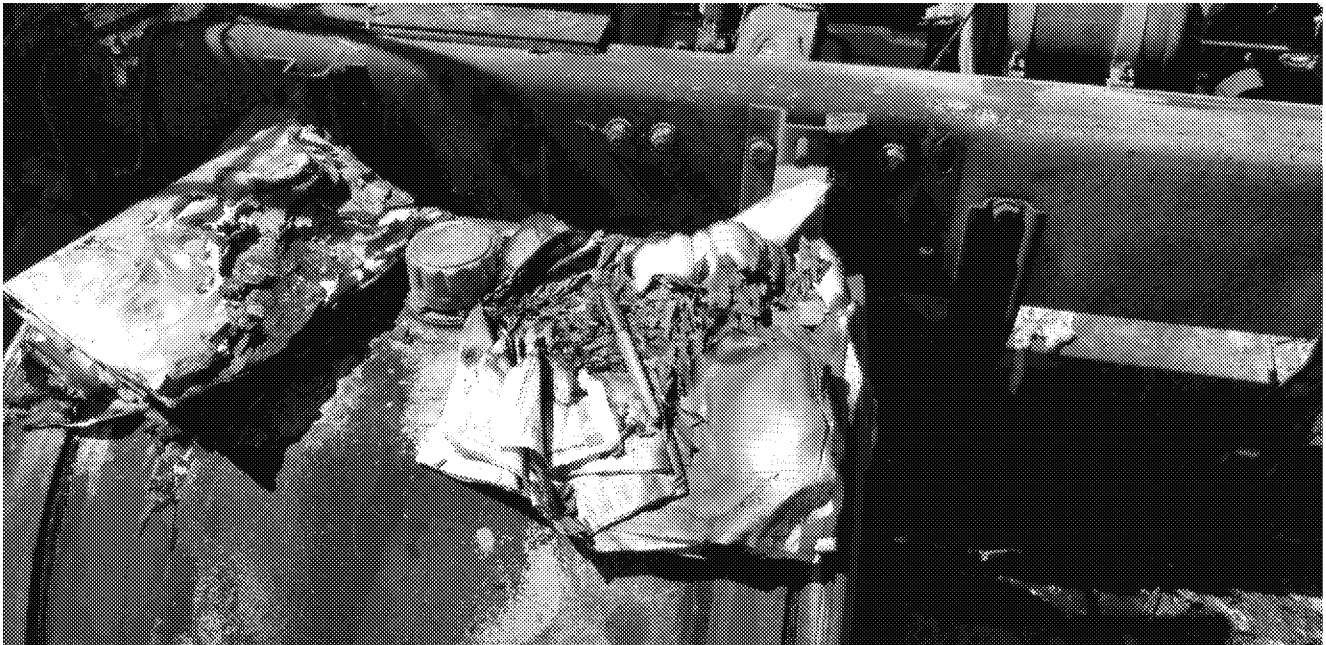
Figure #36.

View facing west at 210 W Slauson Ave, Parcel A, with fire-damaged documents on vehicle pictured in Figure 30.

was about 1/3 full with liquid (it was later determined by WPD's relief team that the depth of the liquid in the tanker was 14 inches). Parcel A also contained two fire-damaged storage trailers and at least two fire-damaged vehicle axles (one appeared to be a tractor). One of the trailers had a CA license plate with number 4GE2731 (Figure 31). Parcel B had less damage to it and contained a few sheds, a pickup truck, a dumpster and a trailer. Most of the damage there was along the metal wall that was splitting the property in half. On the burned tractor, some paperwork was found with a company label and address on the header – Elite Fuel Transportation Inc., PO Box 841, Bloomington, California 92316 (phone number 951-274-0555) (Figure 36). Black soot, charred materials and LAFD's fire suppression foam covered the property.

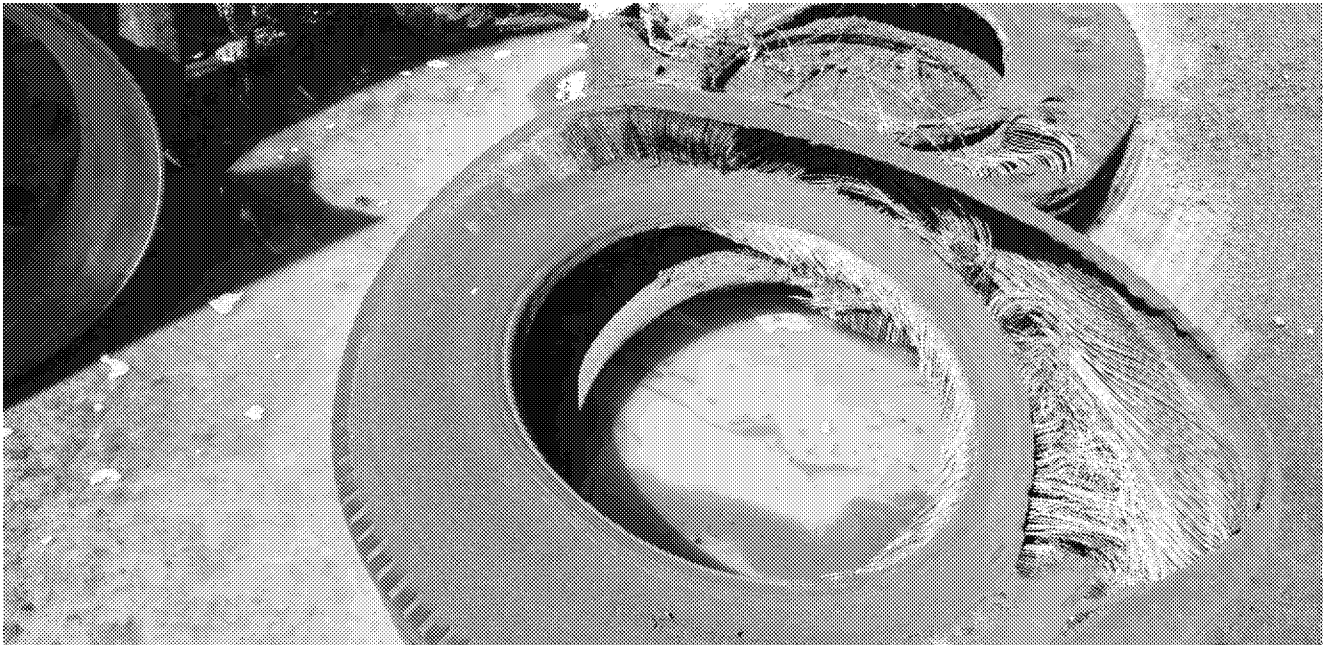
Figure #37.

Downward view of fire-damaged tires and ground near vehicle pictured in Figure 30. Ground pooling likely a mixture of fuel, water and fire retardant.

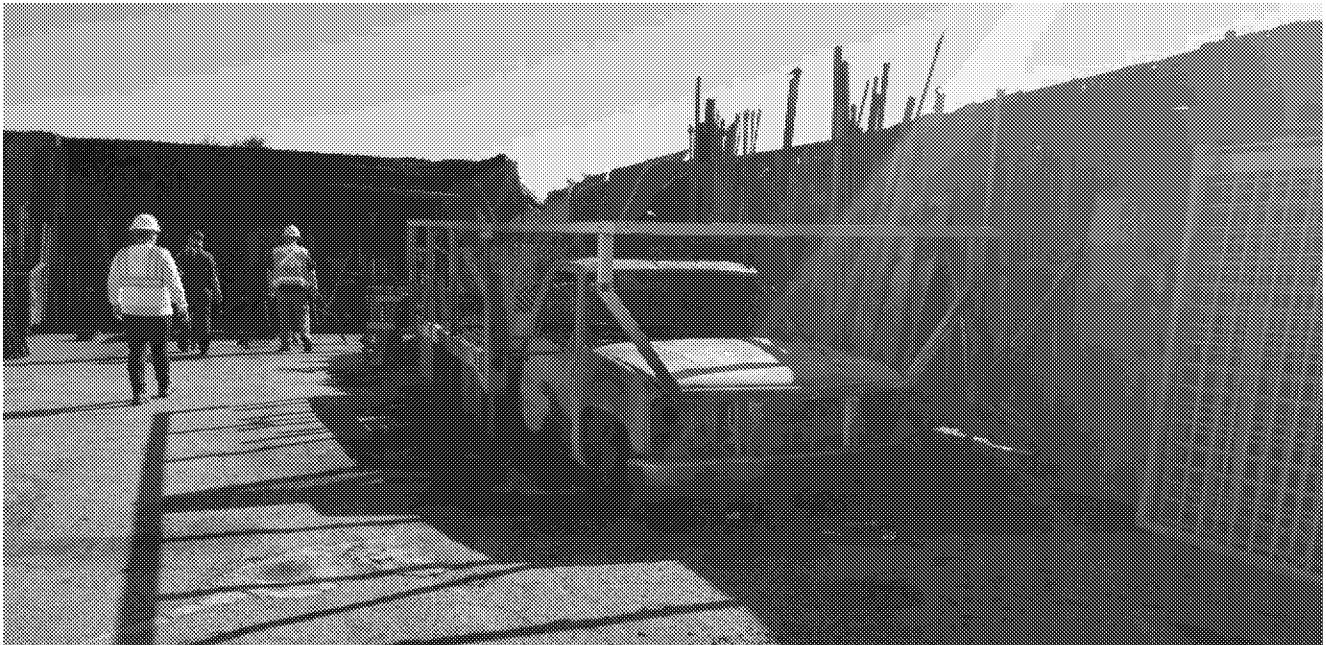
Figure #38.

View facing southwest at 210 W Slauson Ave, Parcel B, with a fire-damaged vehicle.

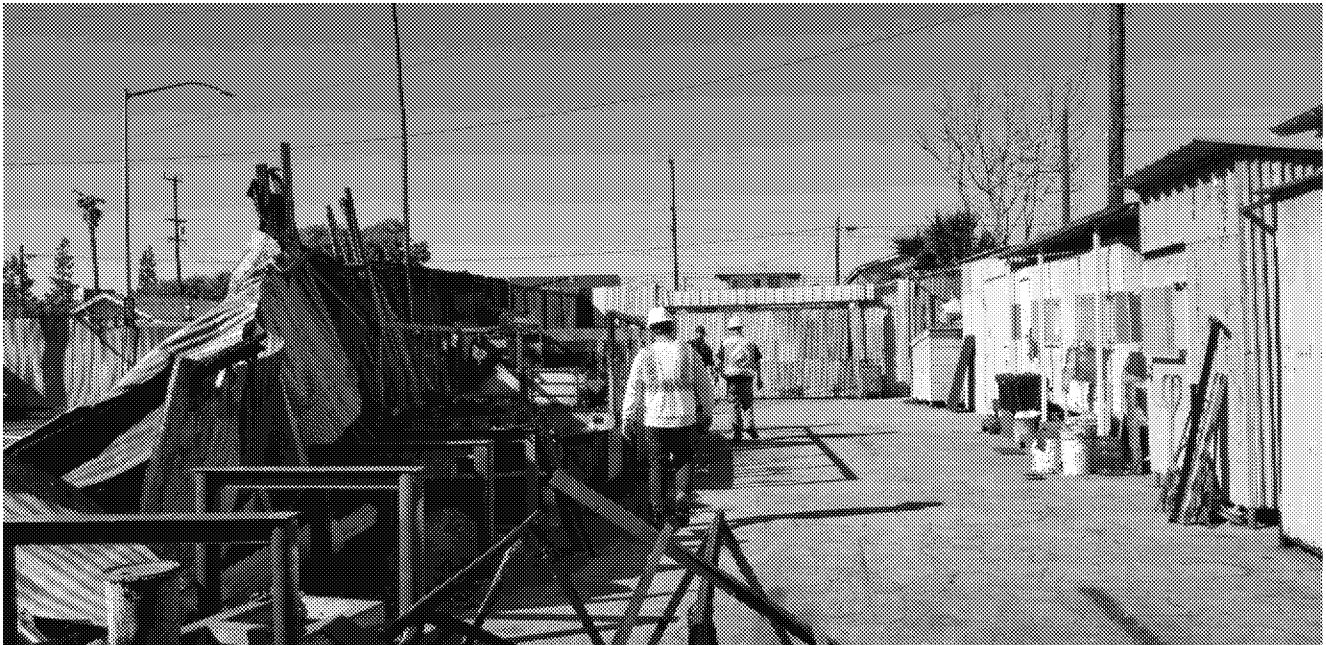
Figure #39.

View facing north at 210 W Slauson Ave, Parcel B, with fire-damaged fencing. Tenant Bryan Chun Choung's white trailer pictured on the right side of photo.

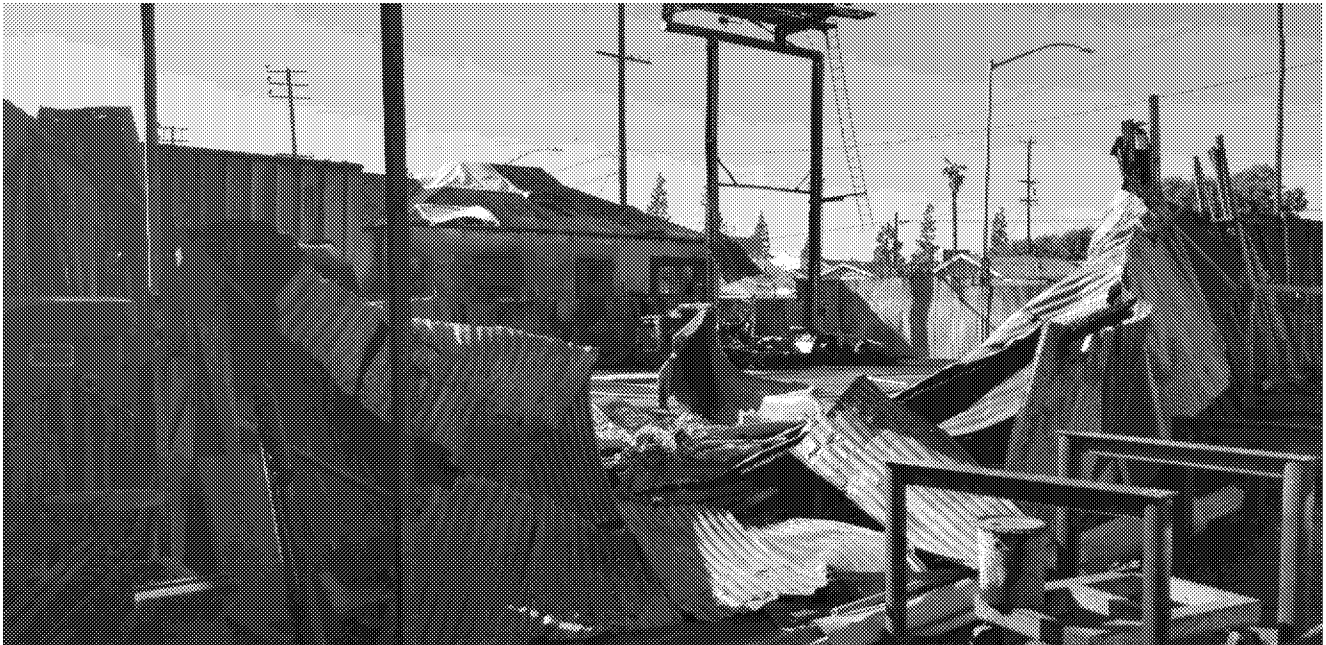
Figure #40.

View facing northwest at 210 W Slauson Ave, Parcel B, looking into Parcel A, with fire-damaged fencing that separated the two parcels.

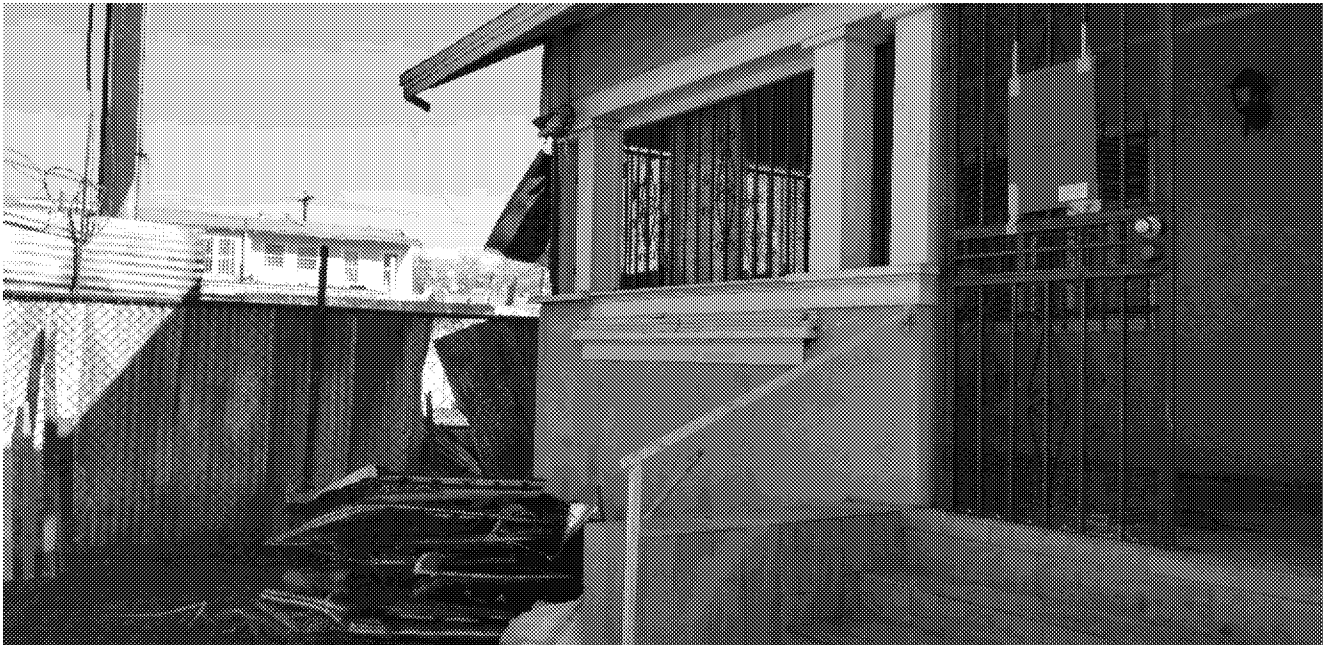
Figure #41.

View facing southeast at 216 W Slauson Ave, with fire-damaged wood on the ground. Red notice taped on door states "Unsafe, do not enter or occupy by order of the City of Los Angeles," in English and Spanish.

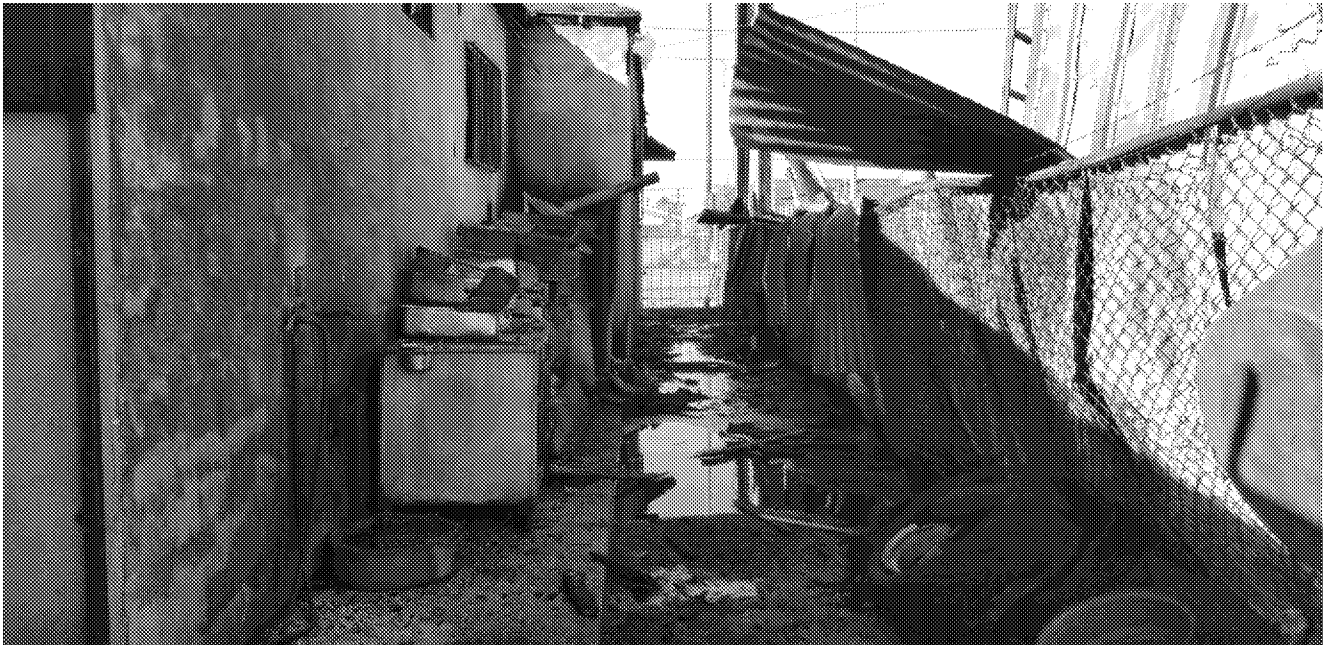
Figure #42.

View facing north at 216 W Slauson Ave, with fire-damaged fencing, walls and appliances pictured. Incident location 210 W Slauson Ave, Parcel A, is located next to this home (east of it). Ground pooling is likely a mixture of fuel, water and fire retardant.

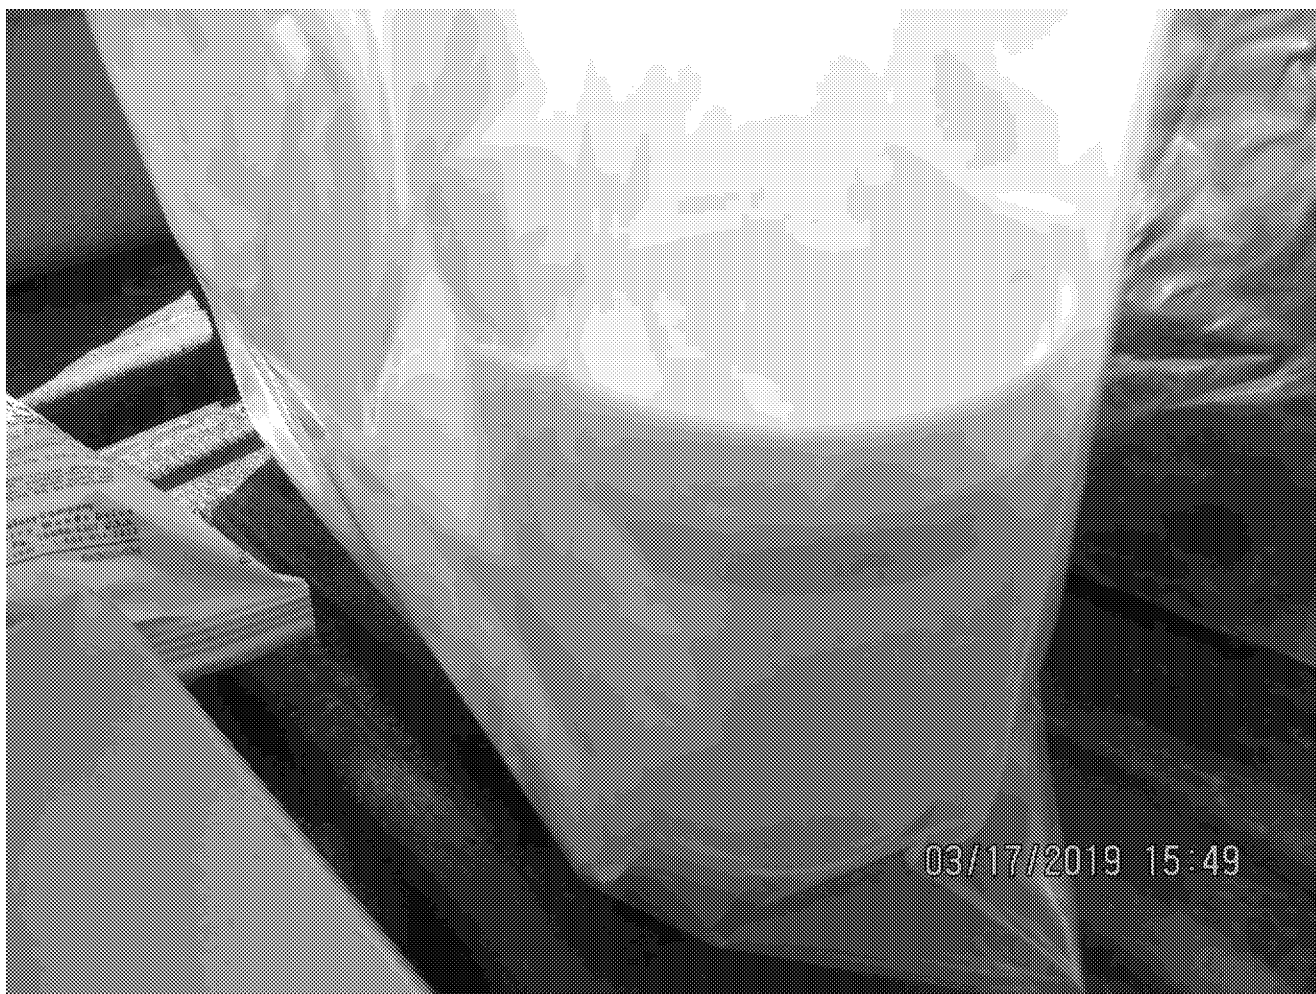
Figure #44.

Close-up view of pre-flush sample #MIT-031719-01, taken from storm drain at W 66th St and Broadway

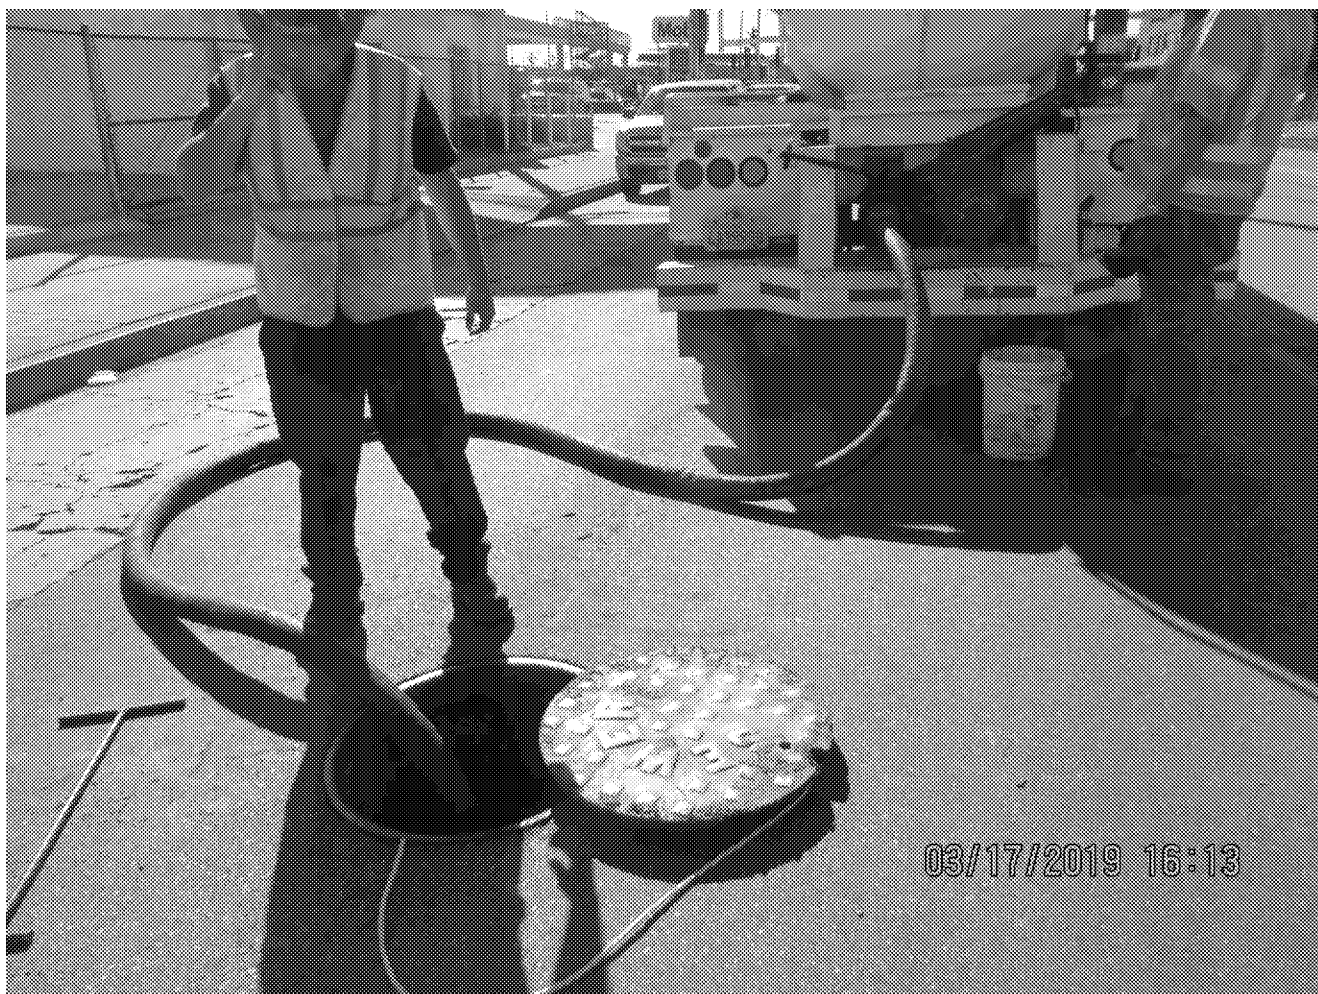
Figure #47.

View facing west along W Slauson Ave at a sewer line getting cleaned by LA County Department of Public Works.

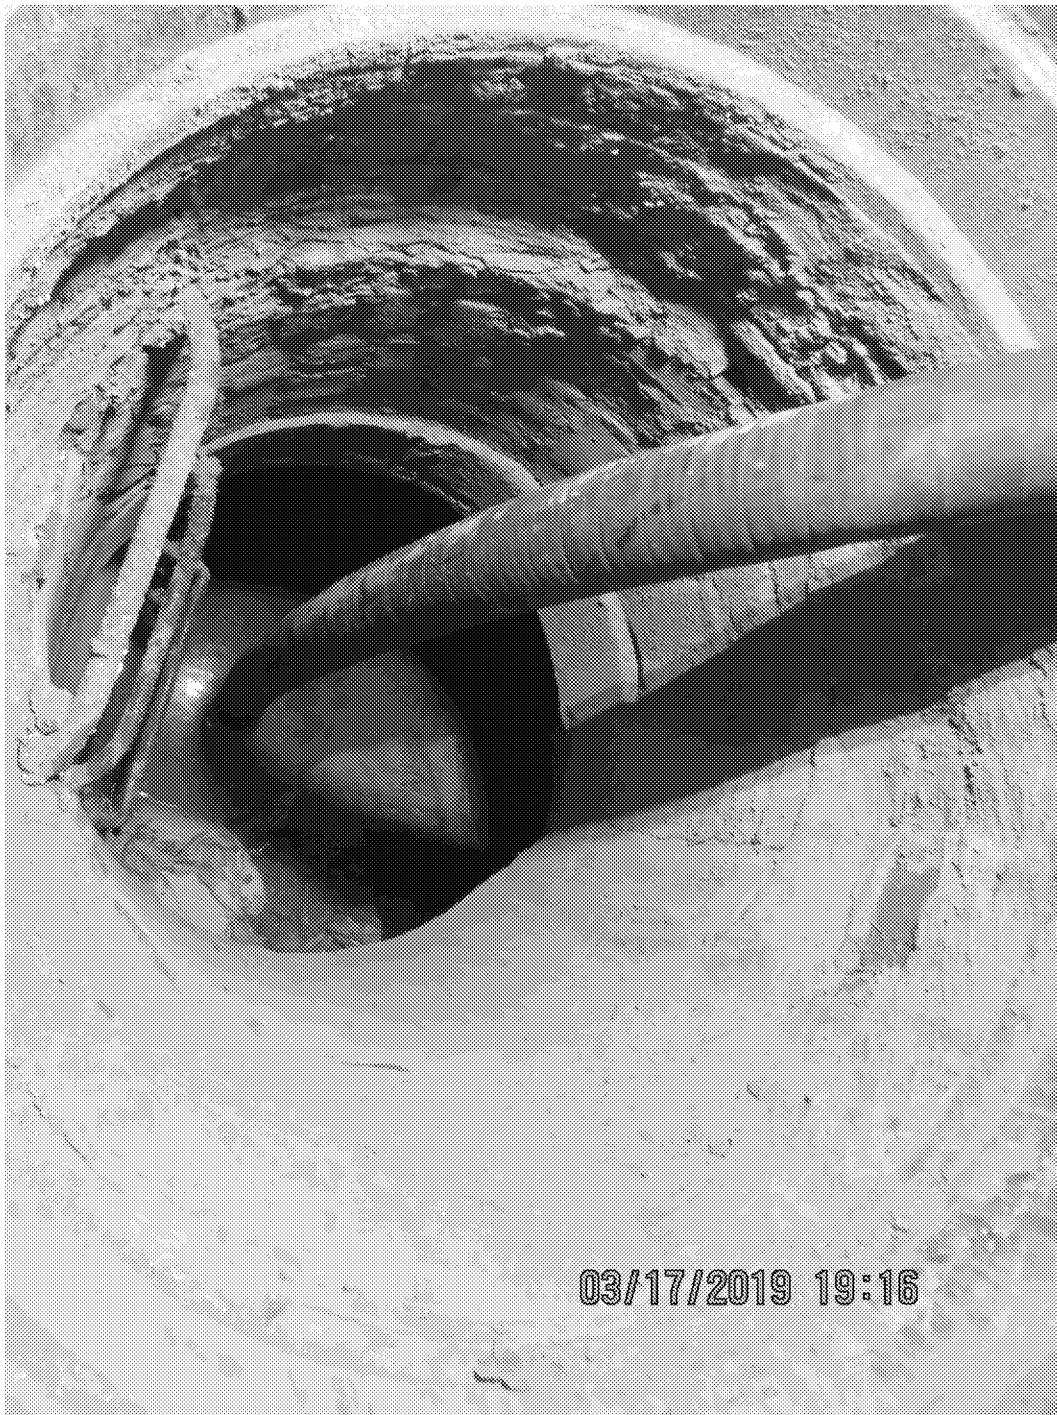
Figure #49.

Downward view inside storm drain #55705466161011 as the fuel/water mixture inside is getting vacuumed by CHES. Also pictured inside the storm drain are booms and barriers placed by CHES.

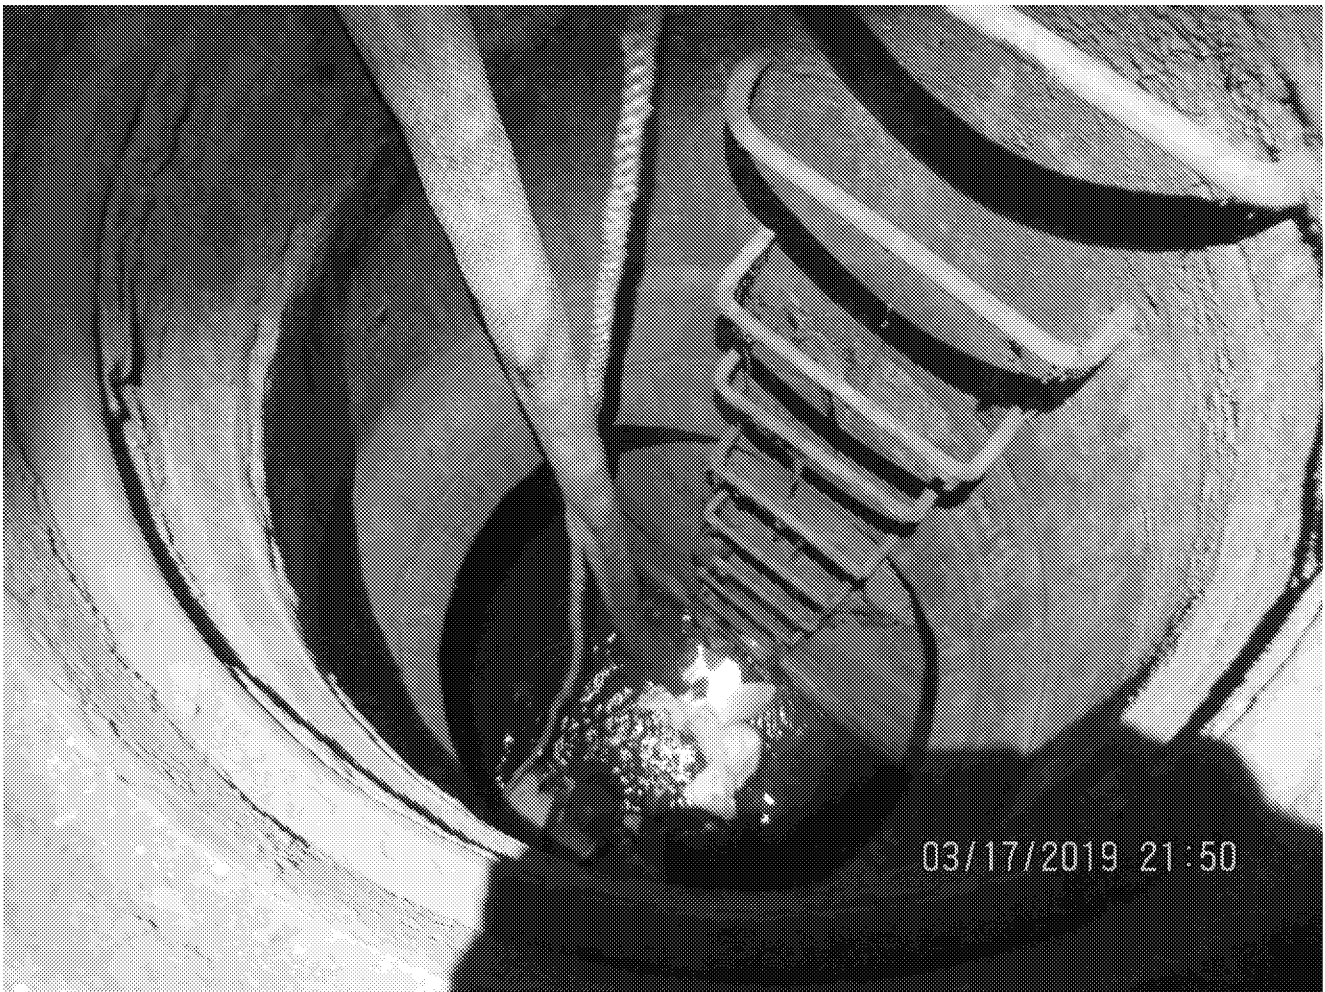
Figure #50.

Downward view inside storm drain #55705466161011 at the end of the storm drain flush operation. CHES Environmental Technician pictured inside the storm drain removing the booms and barriers.

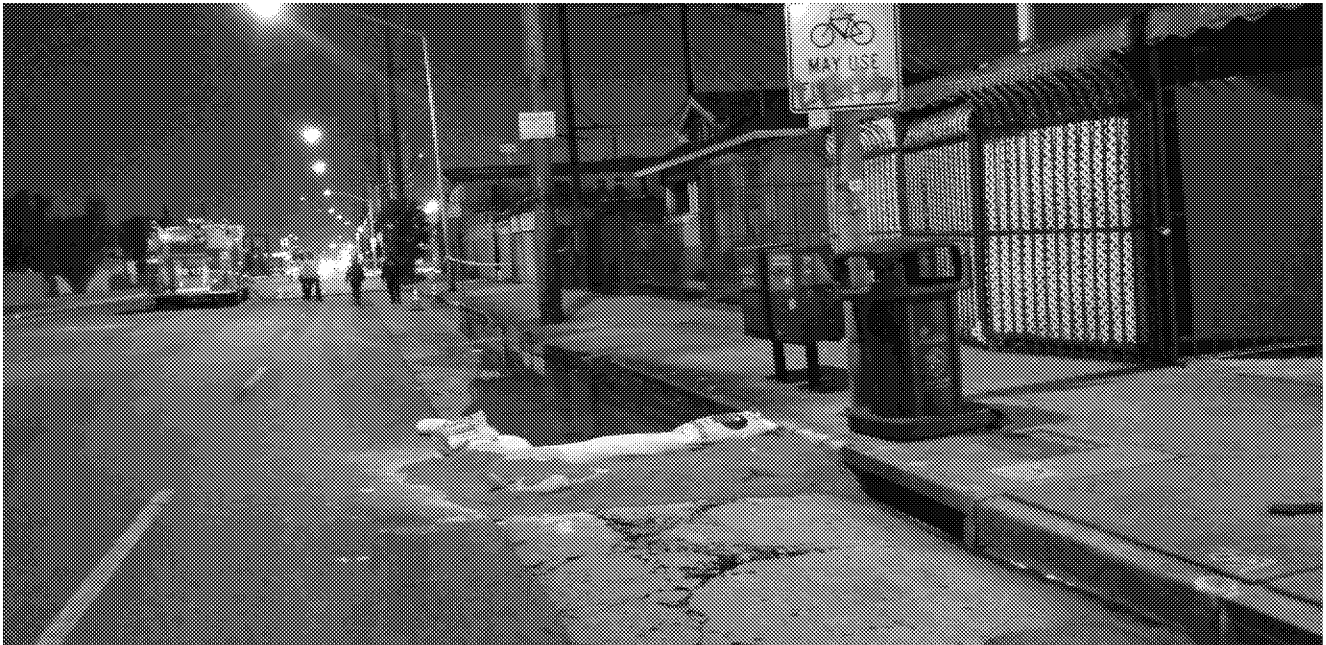
Figure #52.

View facing east along W Slauson Ave at storm drain catch basin #55701461111100 after storm drain flush operation completed. Absorbent and (likely) fuel/water/fire retardant mixture pictured was cleaned by CHES after my departure from the site on March 17, 2019.
[Photo by Cook 3/17/19]
